Noyack

High Water Mark Field Form

DATE: 11/5/12 STORM: Sandy PARTY: ACS / BJM / TCM

SITE NAME: HWM-NY-SUF-432 LATITUDE (DD to 6 places): 40.9937
(Site Name Format: HWM-SS-COU-###, where SS = state, COU = county, ### = site number)

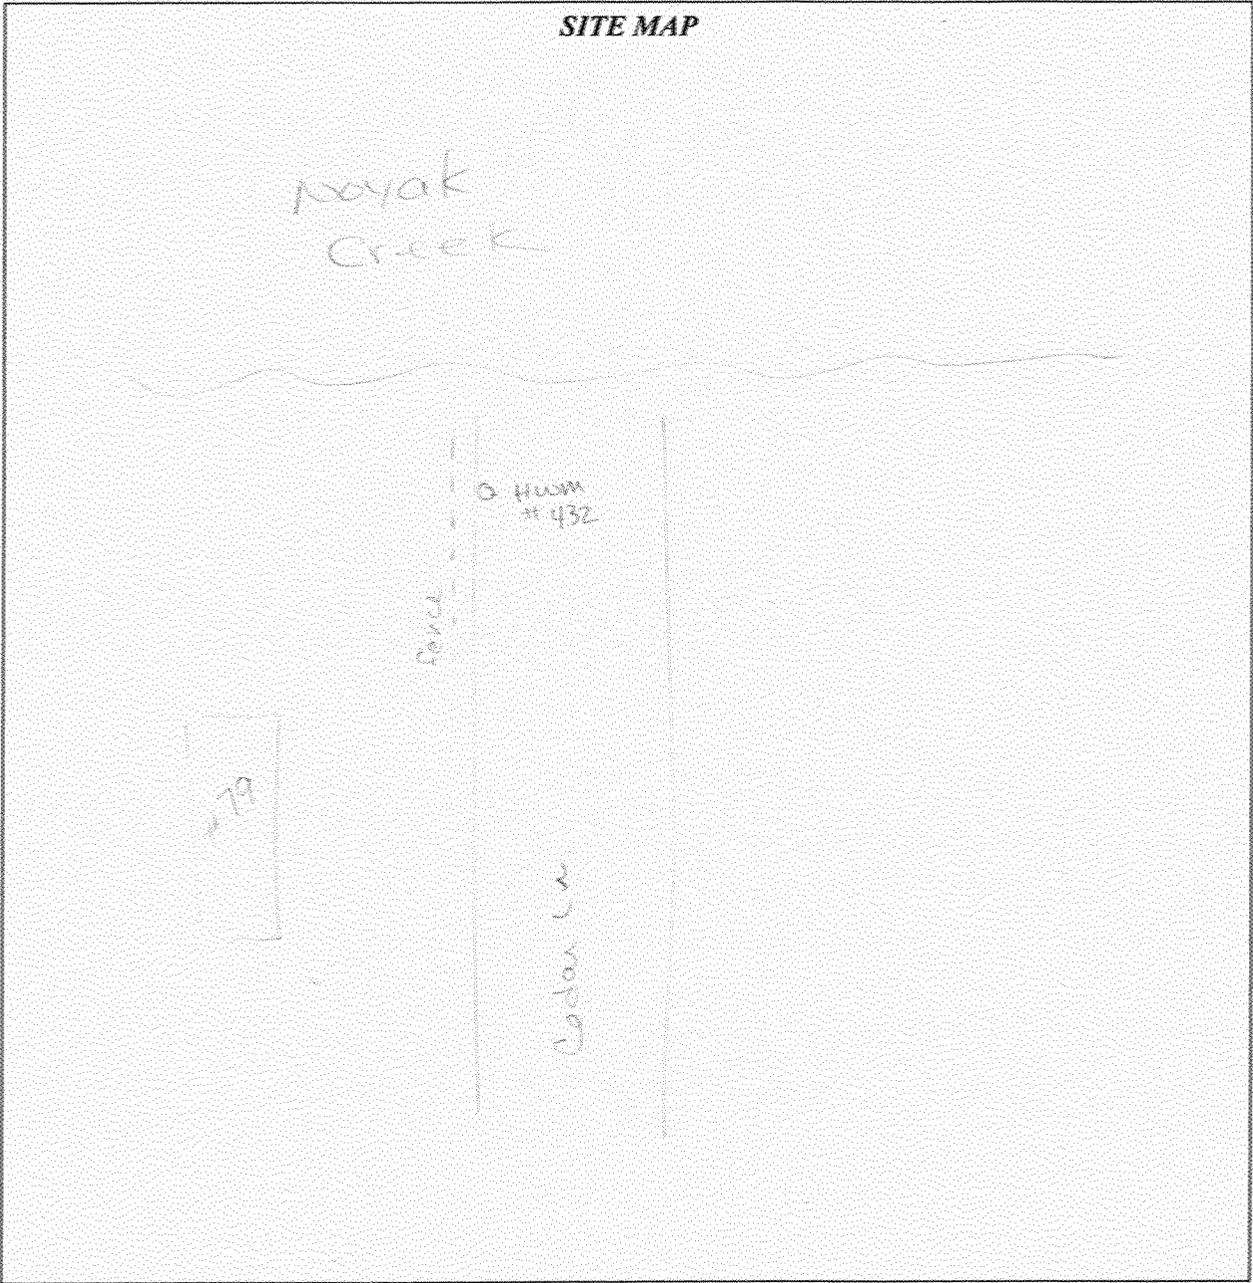
HWM Description: seed line on tree by fence along N side of Cedar lane, in front #79
South 25.5' from centerline of 51' West
from end of fence

Check HWM on fence & tree
note: secondary mark, incidentally labeled
on fence
