High Water Mark Field Form

DATE: 11/3/2012 STORM: Sandy PARTY: CAS / KAC

SITE NAME: HWM-NJ-MON-202 **LATITUDE (DD to 6 places):** 40.40464
(Site Name Format: HWM-SS-COU-###, where SS = state, COU = county, ### = site number)

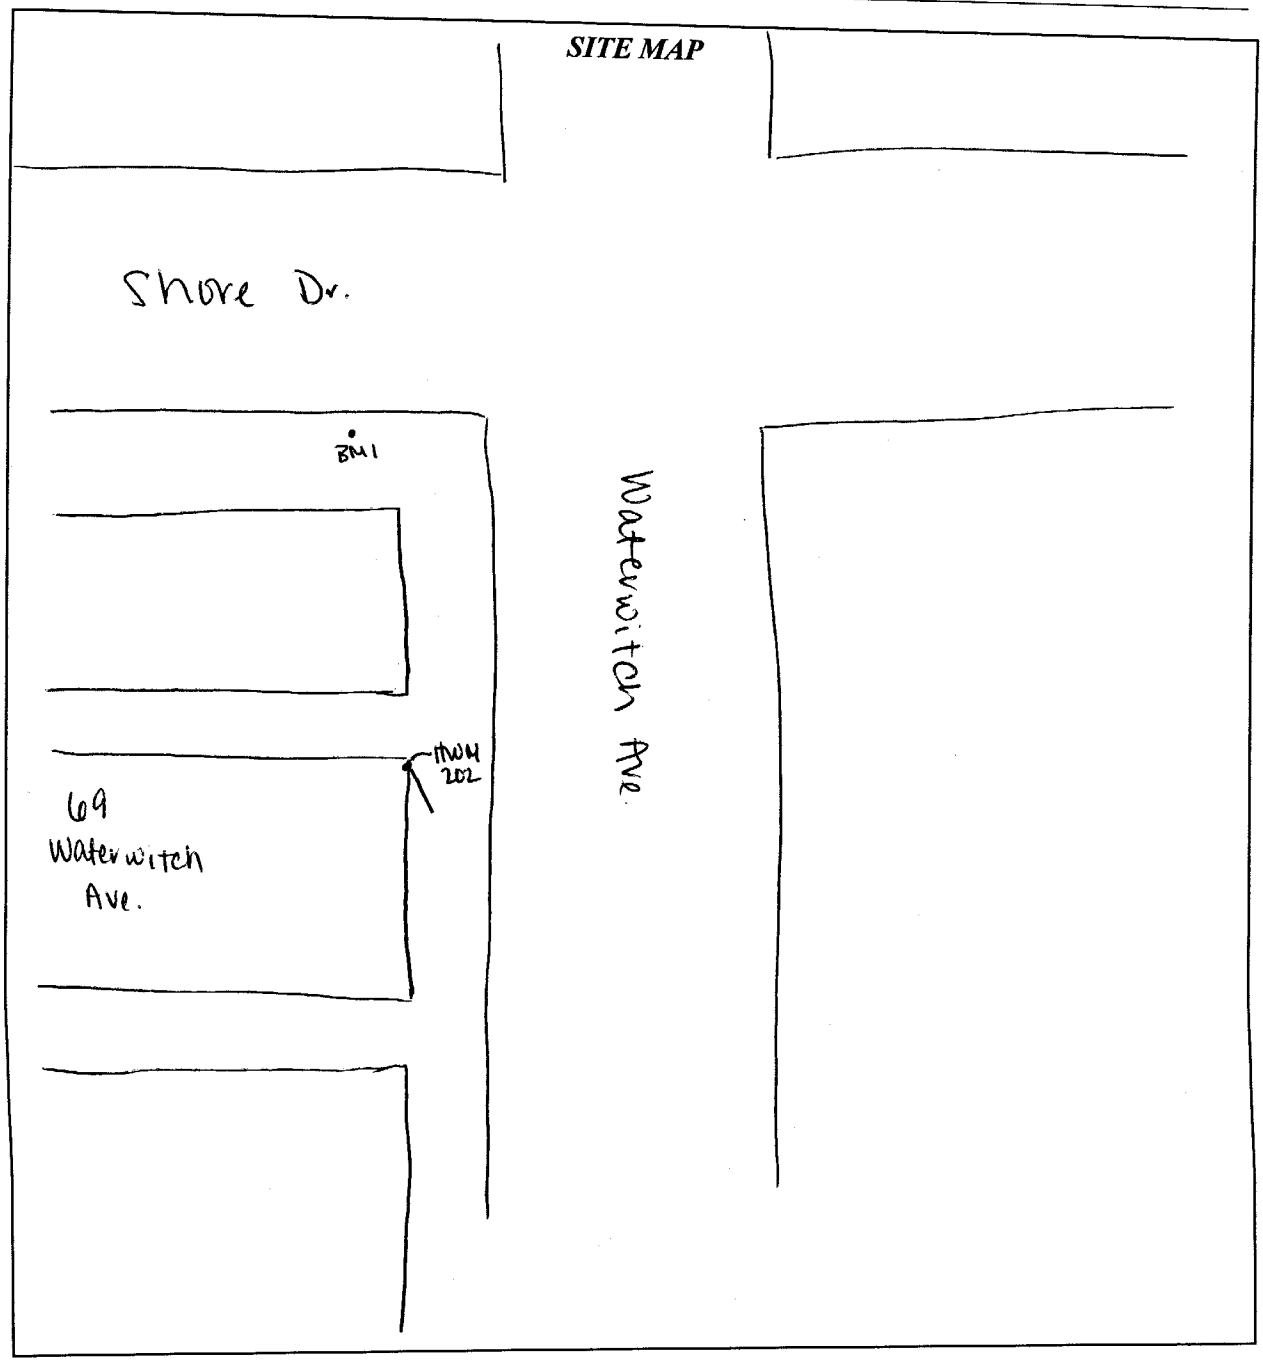
SITE MAP

HWM Description: Mud line inside store on right wall upon entrance to store. Store front is approx. 15' from south edge of road. HWM marked nail installed on inside door frame on right. (In the Garden Shop)

STATION	B.S.	HT.INST	F.S.	ELEV-ATION	REMARKS
BM1	2.646	9.318		6.672	
HWM202			-1.662	10.980	4.8 ft above ground
TP1	2.630	9.314	2.634	6.684	
HWM202			-1.675	10.989	
BM1			2.644	6.670
