High Water Mark Field Form

DATE: 11/2/12 STORM: Sandy (2012) PARTY: WDC / MDC

SITE NAME: HWM-NY-NAS-709 **LATITUDE (DD to 6 places):** 40.593357
(Site Name Format: HWM-SS-COU-###, where SS = state, COU = county, ### = site number)

SITE DESCRIPTION: Long Beach Ice Arena **LONGITUDE (DD to 6 places):** 73.668923

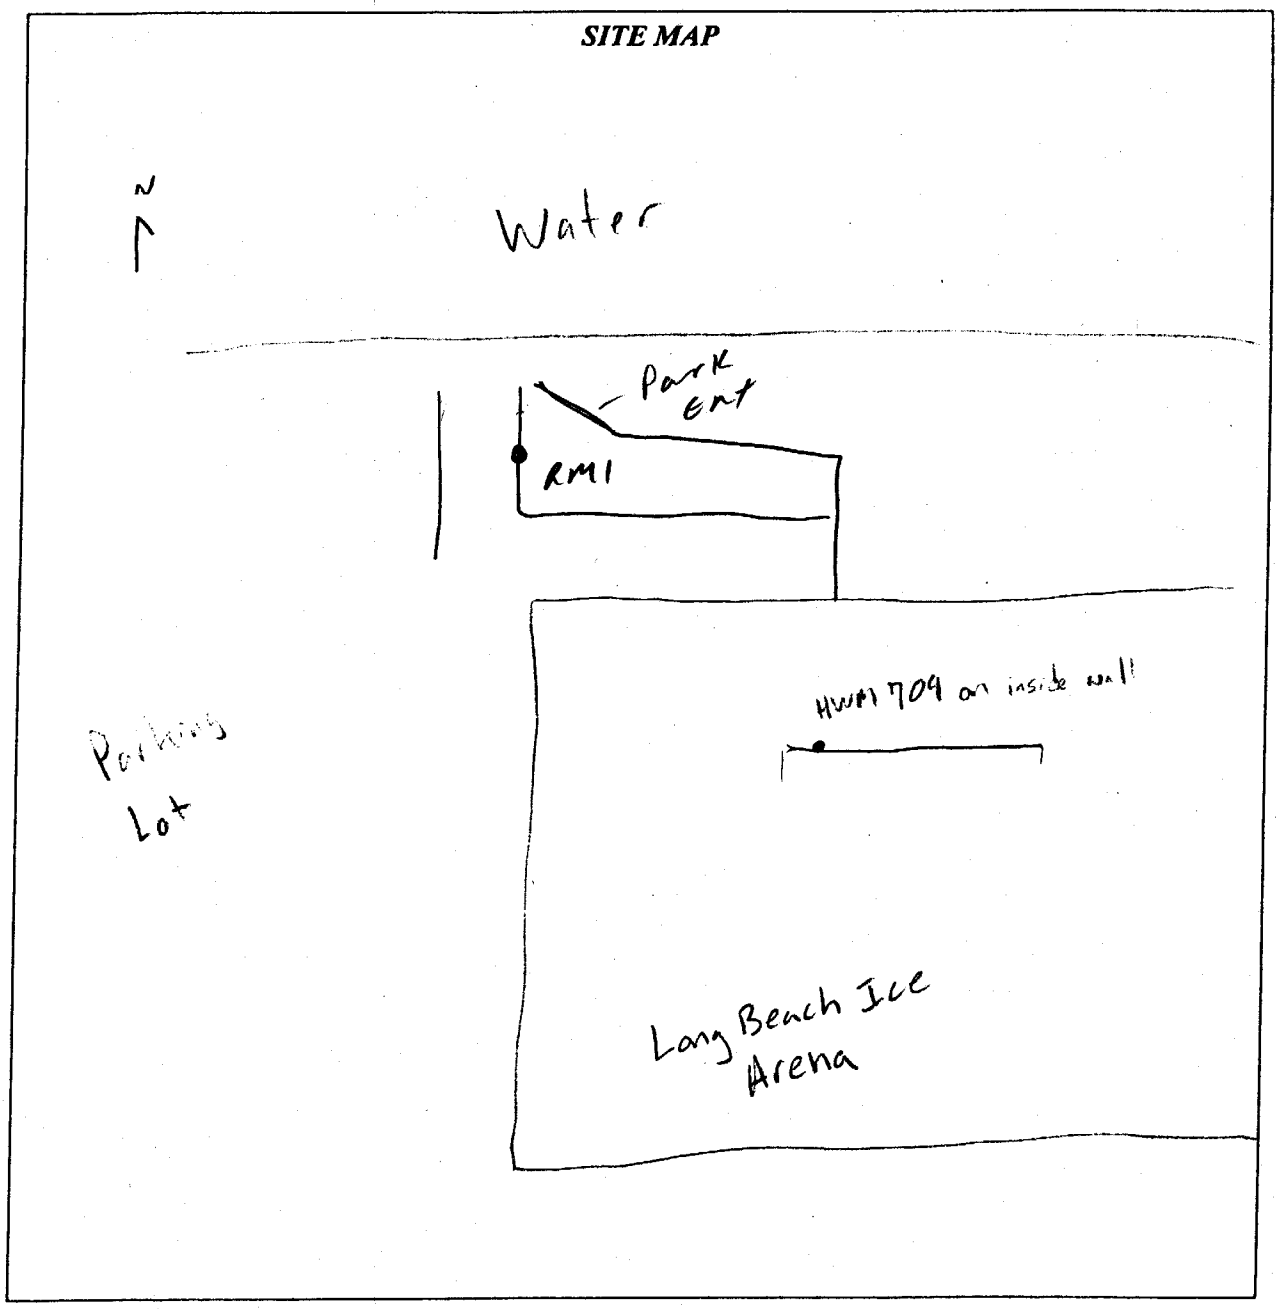
SITE MAP

HWM Description: Mark on top of excellent wash line on wall inside Long Beach Ice Arena

RM Description: Concrete anchor set in curb between park gate & Arena Entrance

RM1 concrete Anchor set in curb between Park Gate & Arena Entrance
