EAST ROCKAWAY

High Water Mark Field Form

DATE: 11/2/2012 12/18/12 STORM: SANDY PARTY: SCF, GEK L.O. Szabo, L.T. Brooks

SITE NAME: HWM - NY - NAS - 916 **LATITUDE (DD to 6 places):** 40.64152

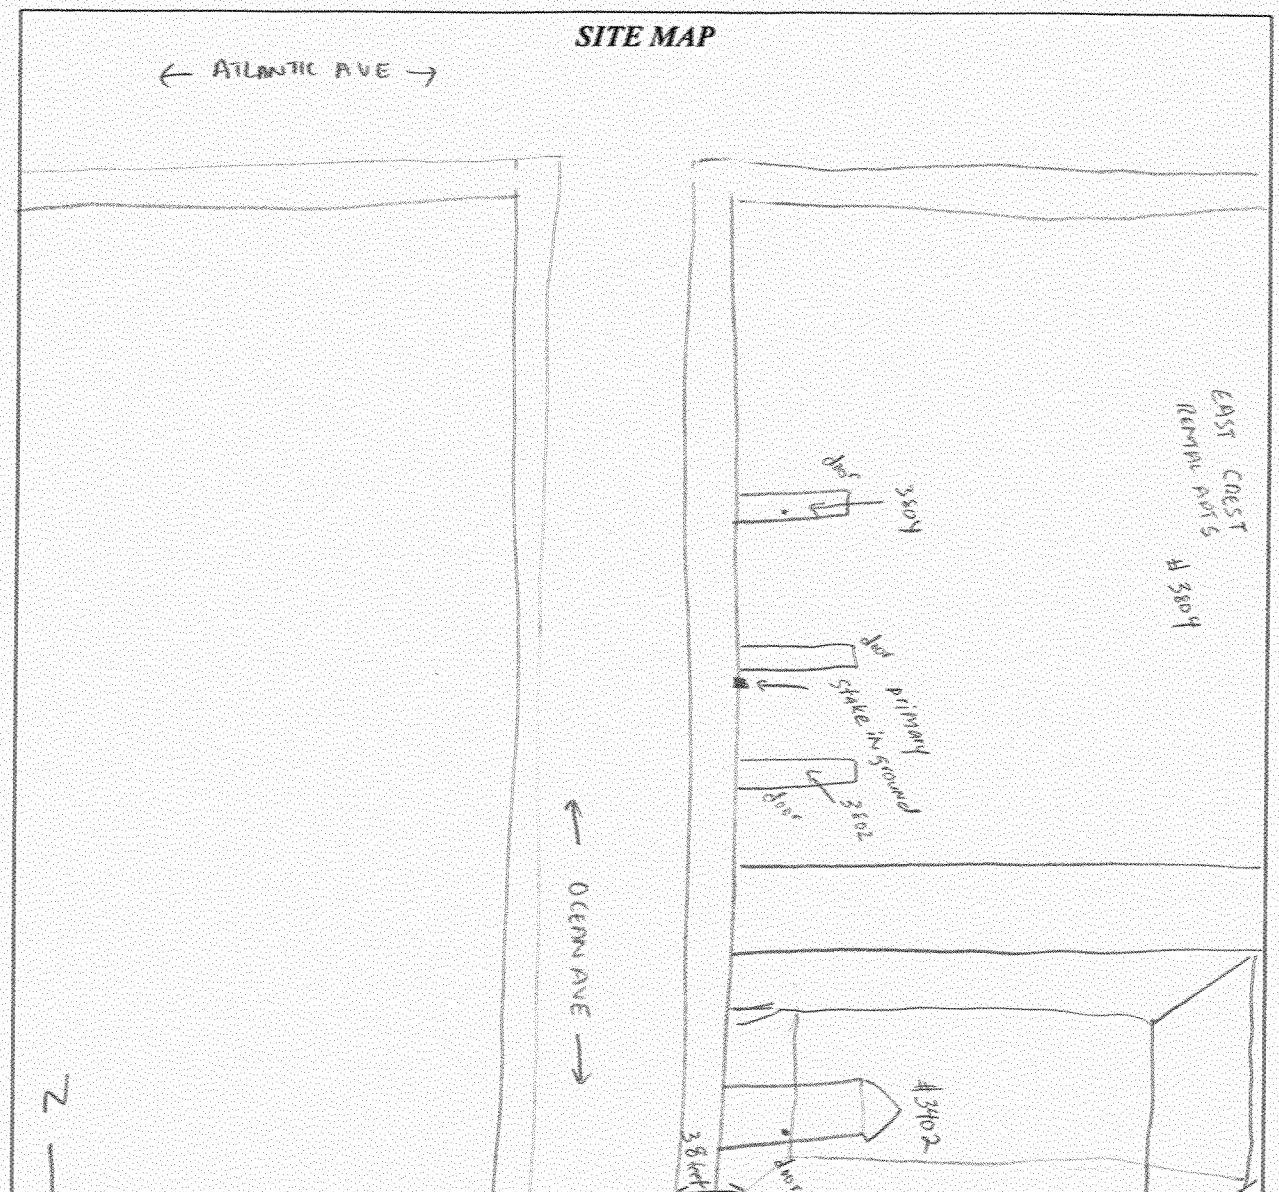
SITE MAP

Survey marker nail inside parking lot

1.78 from nail

secondary

survey marker in ground, corner of building
