High Water Mark Field Form

NAS-922
Quick Lookup #

SITE NAME: HWM - NY - NAS-922 **LATITUDE (DD to 6 places):** 40.64760

SITE DESCRIPTION: 1762 IRENE STREET **LONGITUDE (DD to 6 places):** -073.55389

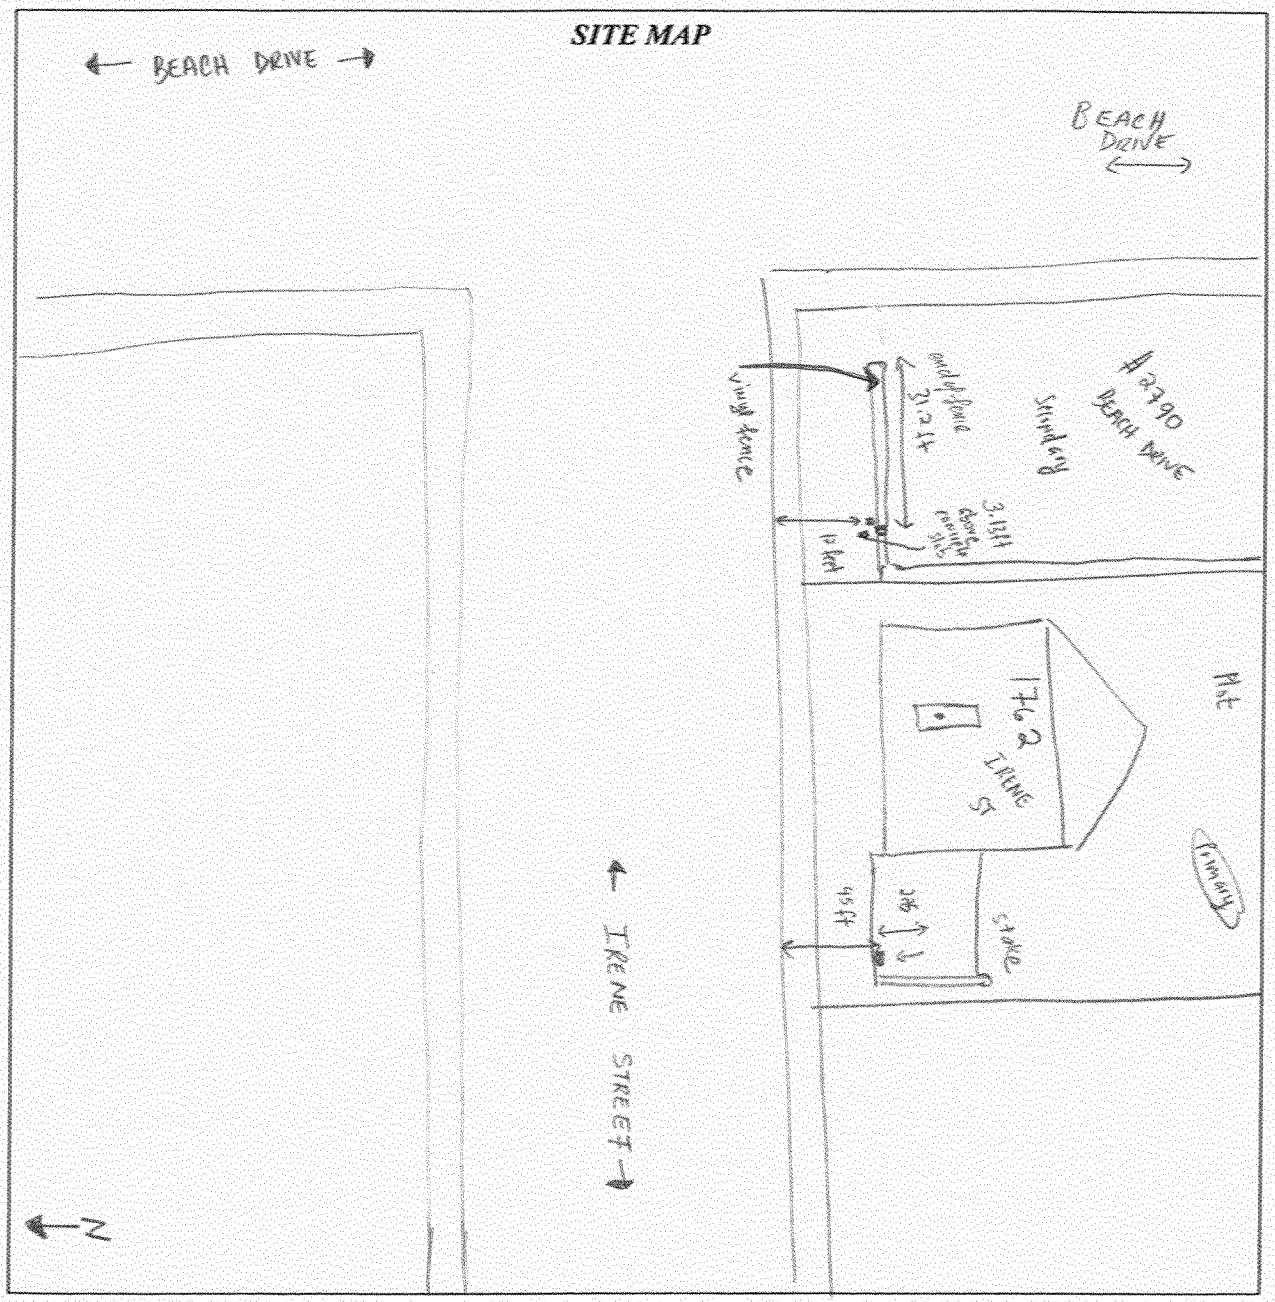
SITE MAP

HWM ON VINYL FENCE AND SIDE OF HOUSE, FRONT OF HOUSE

HWM Description: Seen clearly on vinyl fence post and side of house and front of house

RM Description: stake driven flush into ground; 45 ft from stake to corner of curb
