# High Water Mark Field Form

DATE: 12/28/2012 STORM: Sandy PARTY: WDC AES

**SITE NAME:** HWM-NY-NEW-001 **LATITUDE (DD to 6 places):** 40.7776
(Site Name Format: HWM-SS-COU-###, where SS = state, COU = county, ### = site number)

**SITE DESCRIPTION:** Carl Schurz Park **LONGITUDE (DD to 6 places):** -73.9425

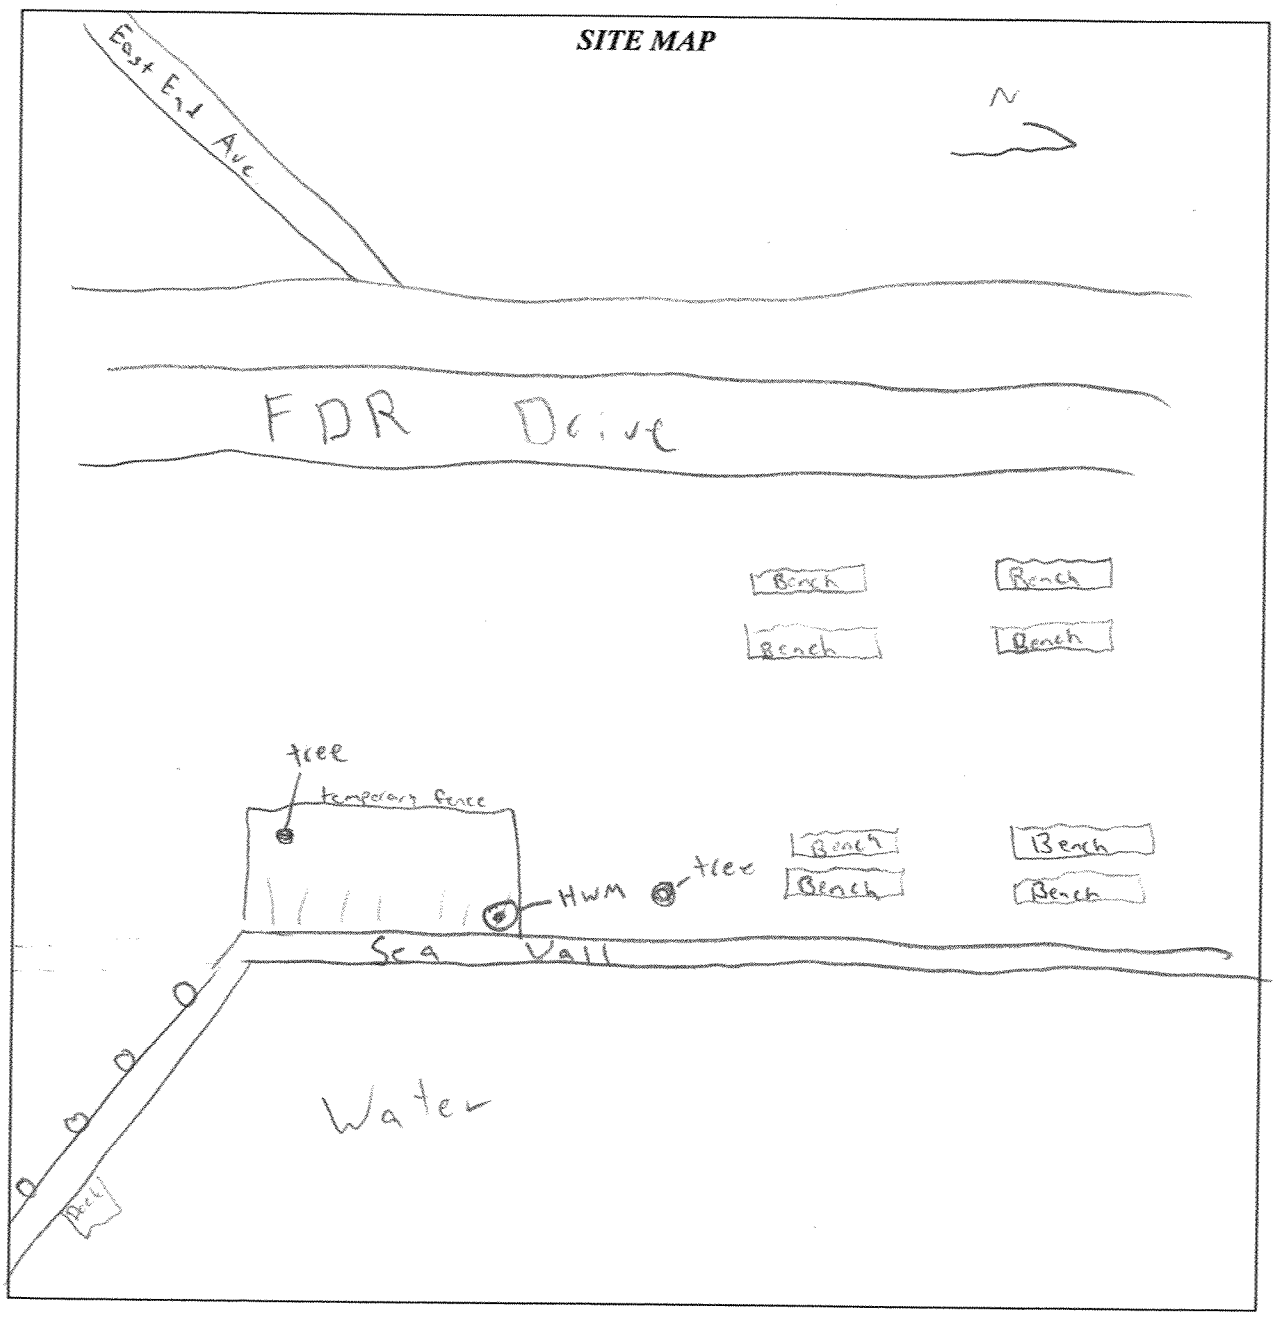
**HWM Description:** Debris line of vegetation in grass North side of fenced area See Sketch

HWM on Ornamental grass

RM - Temporary wooden stake

HWM = RM Elevation + T-pcup

9.052 + 1.381
