High Water Mark Field Form

NEW - 004
Quick Lookup #

SITE NAME: HWM – NY – NEW – 004 **LATITUDE (DD to 6 places):** 40.76312
(Site Name Format: HWM-SS-COU-###, where SS = state, COU = county, ### = site number)

SITE DESCRIPTION: Pier 84 by Intrepid **LONGITUDE (DD to 6 places):** -74.00047

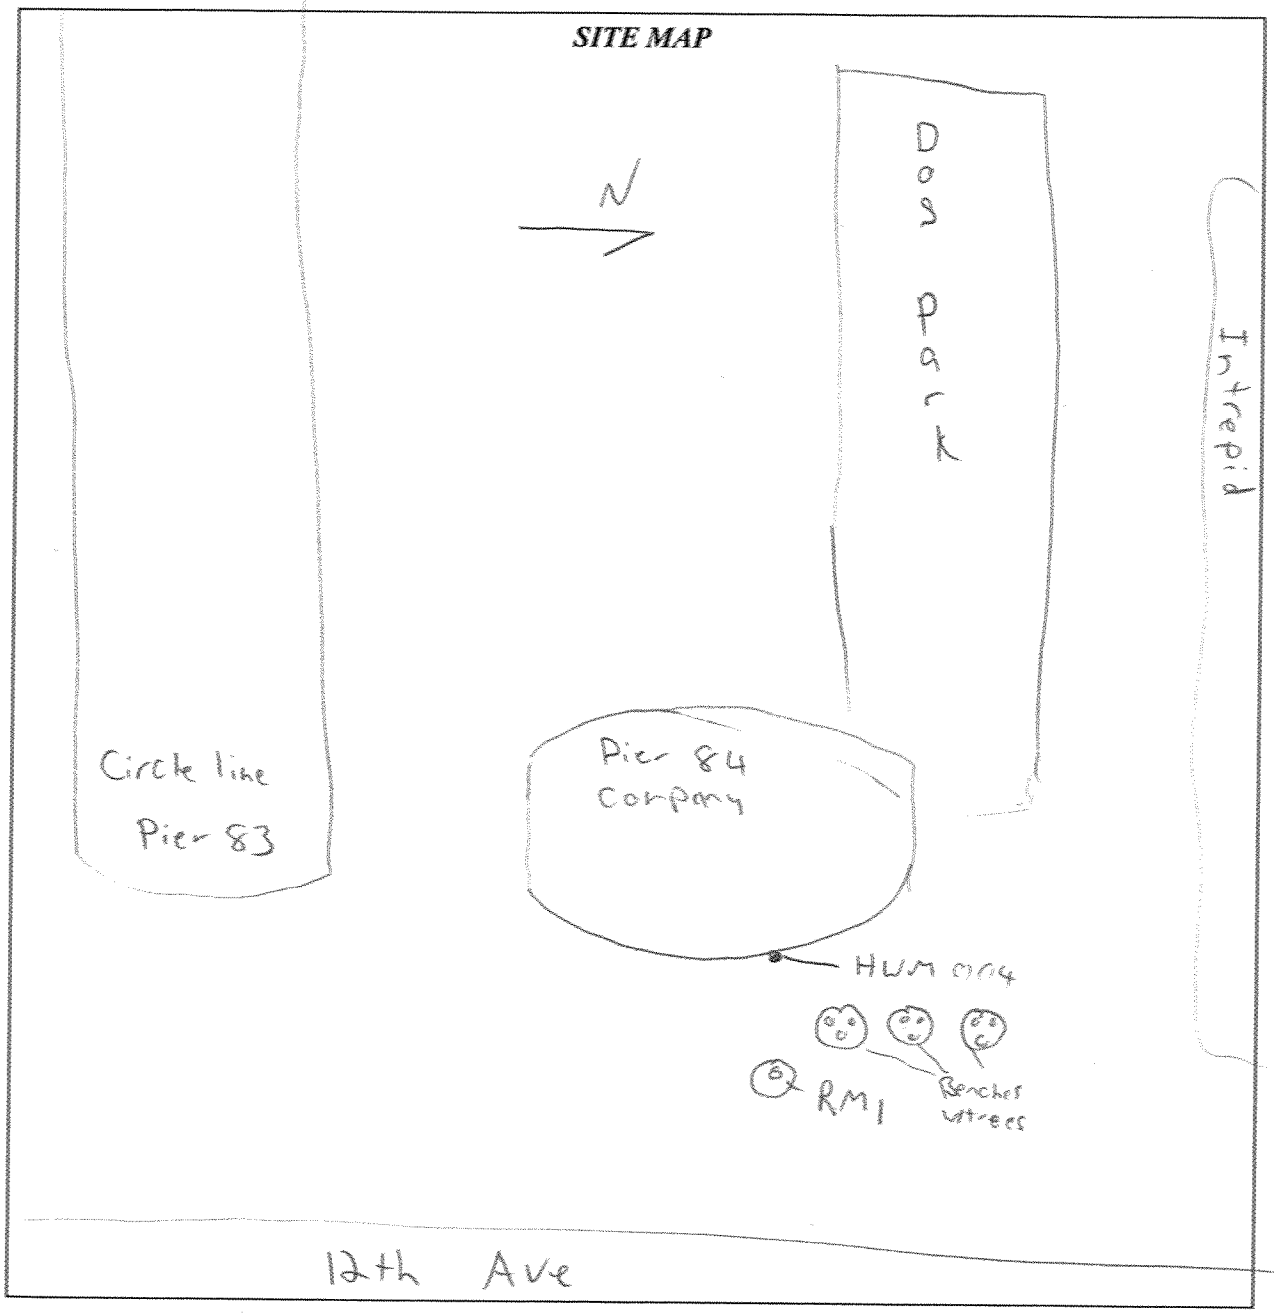
SITE MAP

HWM is seedline on back side of Pier 84 Company building
