U.S. Department of the Interior
Geological Survey
High-Water Mark Documentation Notes

Date of Flood: Oct 29, 2012

County : NY - NY

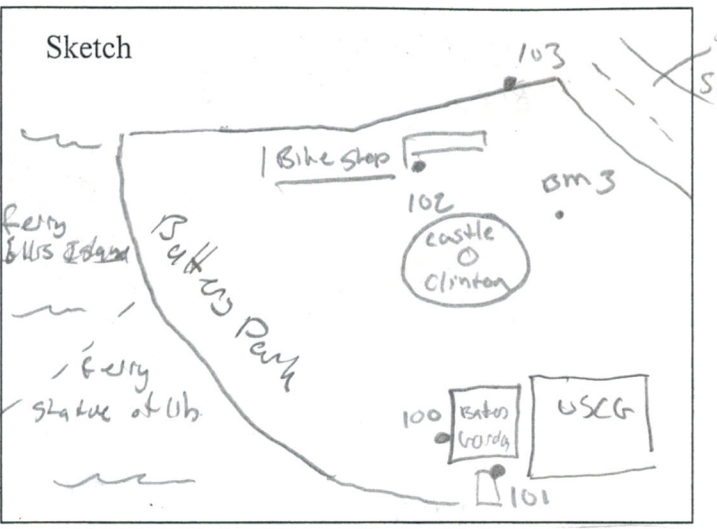
Sketch

NY - NY
HWM# 100 Elevation 11.55 GPS reading: lat 40 42 ' 04 " long 74 00 ' 56 " (good /poor)
Mark condition (Circle one) excellent / good / fair / poor Photo # 1
HWM is: seed /mud /debris line /other (describe) outside structure found HWM on (describe) window on Lft / Rt bank
HWM is: _____ ft. US / DS / Lft / Rt of bridge / house no. _____ / bldg no. _____, and is _____ ft. above ground
HWM marked with: paint / hub / rebar / nail / PK nail / chiseled mark / other (describe) Sharpy
Comments: on outside window SW side of Battery Bosdens
TU = 247

HWM# 101 Elevation 11.37 GPS reading: lat 40 42 ' 04 " long 74 00 ' 54 " (good /poor)
NY-NY Mark condition (Circle one) excellent / good / fair / poor Photo # 2
HWM is: seed /mud /debris line /other (describe) wall found HWM on (describe) patio on Lft / Rt bank
TU=2.34 HWM is: _____ ft. US / DS / Lft / Rt of bridge / house no. _____ / bldg no. _____, and is _____ ft. above ground
from ground HWM marked with: paint / hub / rebar / nail / PK nail / chiseled mark / other (describe) Sharpy HWM2
Comments: mud line in patio wall protected by Battery Garden building and outside chicken

HWM# 102 Elevation 11.02 GPS reading: lat 40 42 ' 16 " long 74 01 ' 01 " (good /poor)
Mark condition (Circle one) excellent / good / fair / poor Photo # 3
NY-NY HWM is: seed /mud /debris line /other (describe) In container found HWM on (describe) door of Bike on Lft / Rt bank Steel container
TU= HWM is: _____ ft. US / DS / Lft / Rt of bridge / house no. _____ / bldg no. _____, and is _____ ft. above ground
5.48 HWM marked with: paint / hub / rebar / nail / PK nail / chiseled mark / other (describe) Sharpy line HWM 2/3
Comments: inside bike rental container on street side door Battery park

NY-NY HWM# 103 Elevation 10.99 GPS reading: lat 40 42 ' 16 " long 74 01 ' 00 " (good /poor)
Mark condition (Circle one) excellent / good / fair / poor Photo # 4
TU= HWM is: seed /mud /debris line /other (describe) line on wall found HWM on (describe) wood fence on Lft / Rt bank
4.30 HWM is: _____ ft. US / DS / Lft / Rt of bridge / house no. _____ / bldg no. _____, and is _____ ft. above ground
HWM marked with: paint / hub / rebar / nail / PK nail / chiseled mark / other (describe) Sharpy line
Comments: old fire station Bear 8 on Battery park wooden construction wall
