Ocean Beach

High Water Mark Field Form

DATE: 11/3/12 STORM: Sandy PARTY: AES/TLM/BJM/CES

SITE NAME: HWM-NY-SUF-419 **LATITUDE (DD to 6 places):** N 40.644
(Site Name Format: HWM-SS-COU-###, where SS = state, COU = county, ### = site number)

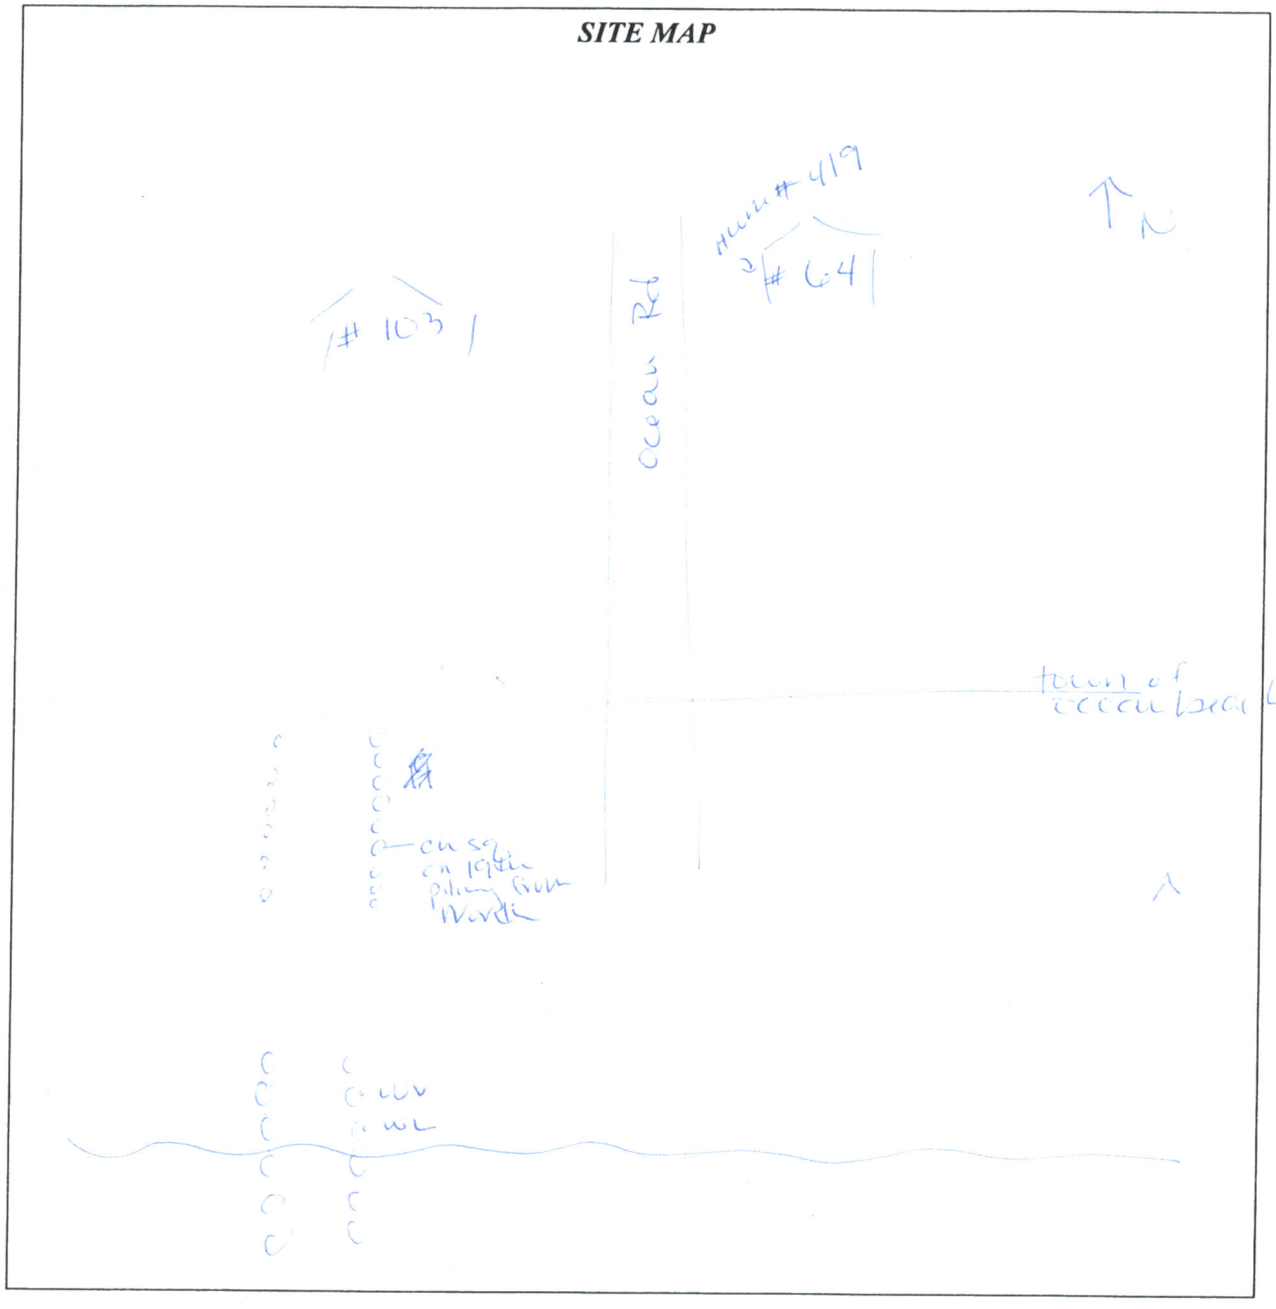
SITE MAP

HWM Description: mud line on foundation of 064 Ocean Rd on "Bonnie Dune" blue house

RM Description: chiseled square on 19th piling from ocean beach town line
