High Water Mark Field Form

DATE: 11/2/12 STORM: Sandy PARTY: ADL/RAS/ESR

SITE NAME: HWM-NY-SUF-509 **LATITUDE (DD to 6 places):** 40.945739
(Site Name Format: HWM-SS-COU-###, where SS = state, COU = county, ### = site number)

SITE DESCRIPTION: Port Jefferson - Barnum Ave. **LONGITUDE (DD to 6 places):** 73.071980

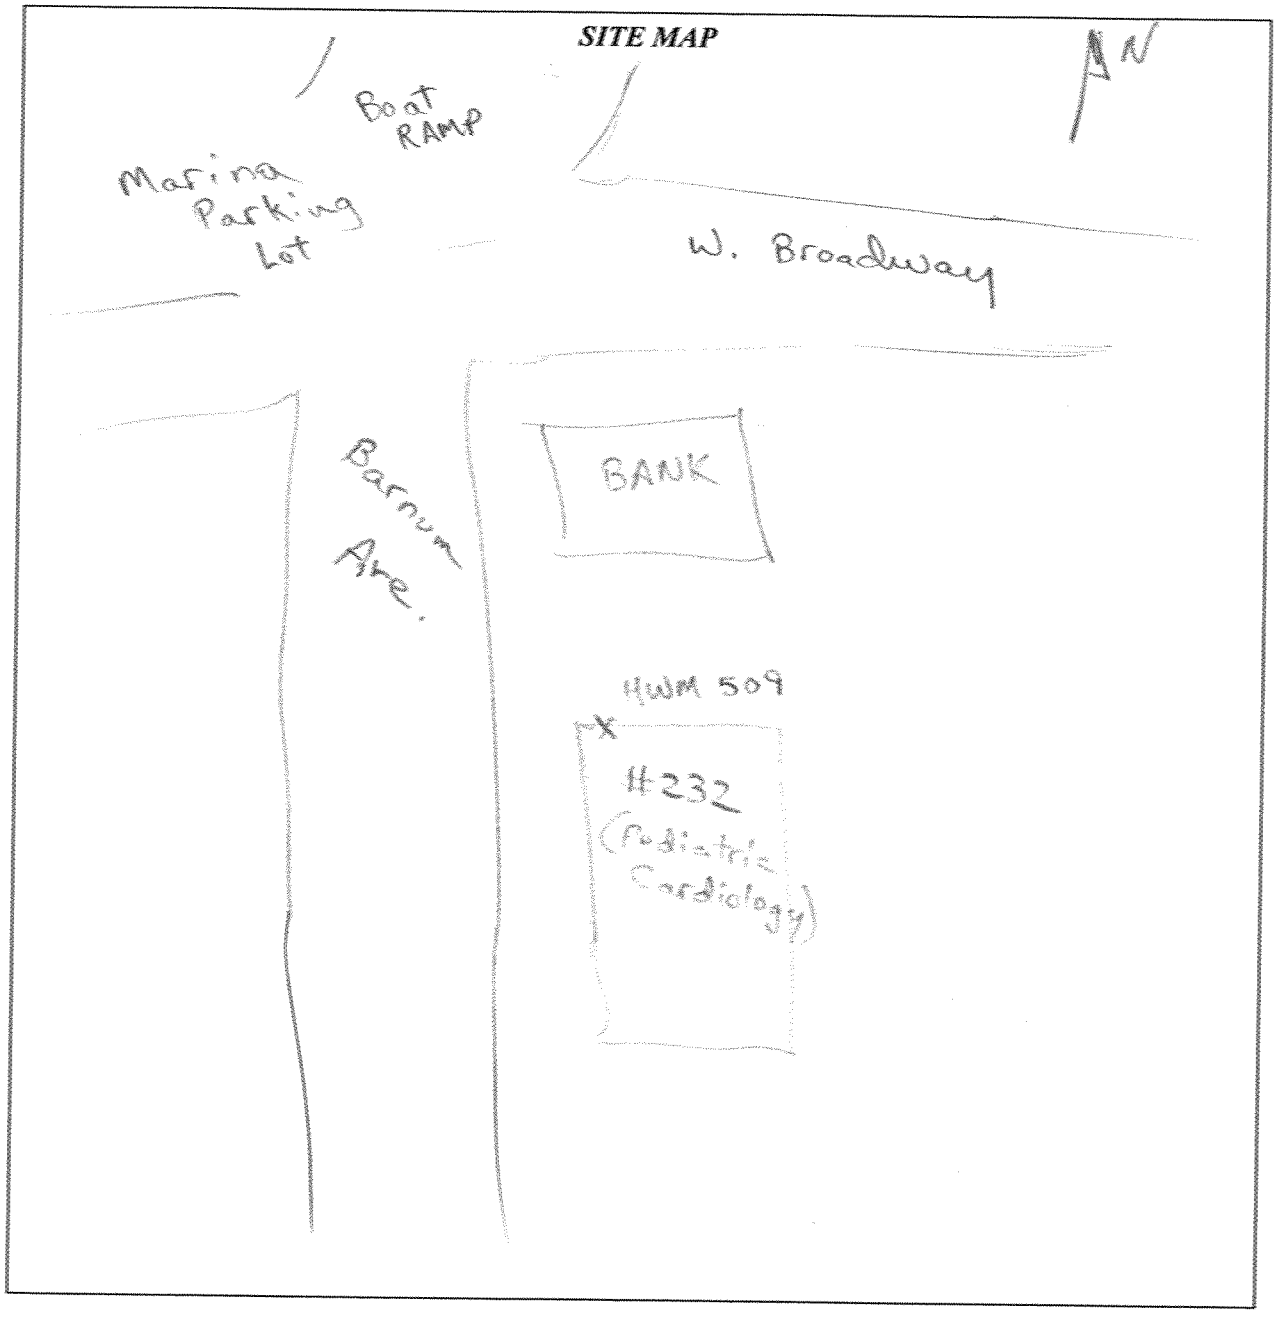
SITE MAP

HWM Description: Seed line on outside of building located @ 232 Barnum Ave. (Pediatric Cardiology)
