# High Water Mark Field Form

SUF-627
Quick Lookup #

DATE: 11/5/12 STORM: Sandy PARTY: JJF/MJS

**SITE NAME:** HWM-NY-SUF-627 **LATITUDE (DD to 6 places):** 40.71995
(Site Name Format: HWM-SS-COU-###, where SS = state, COU = county, ### = site number)

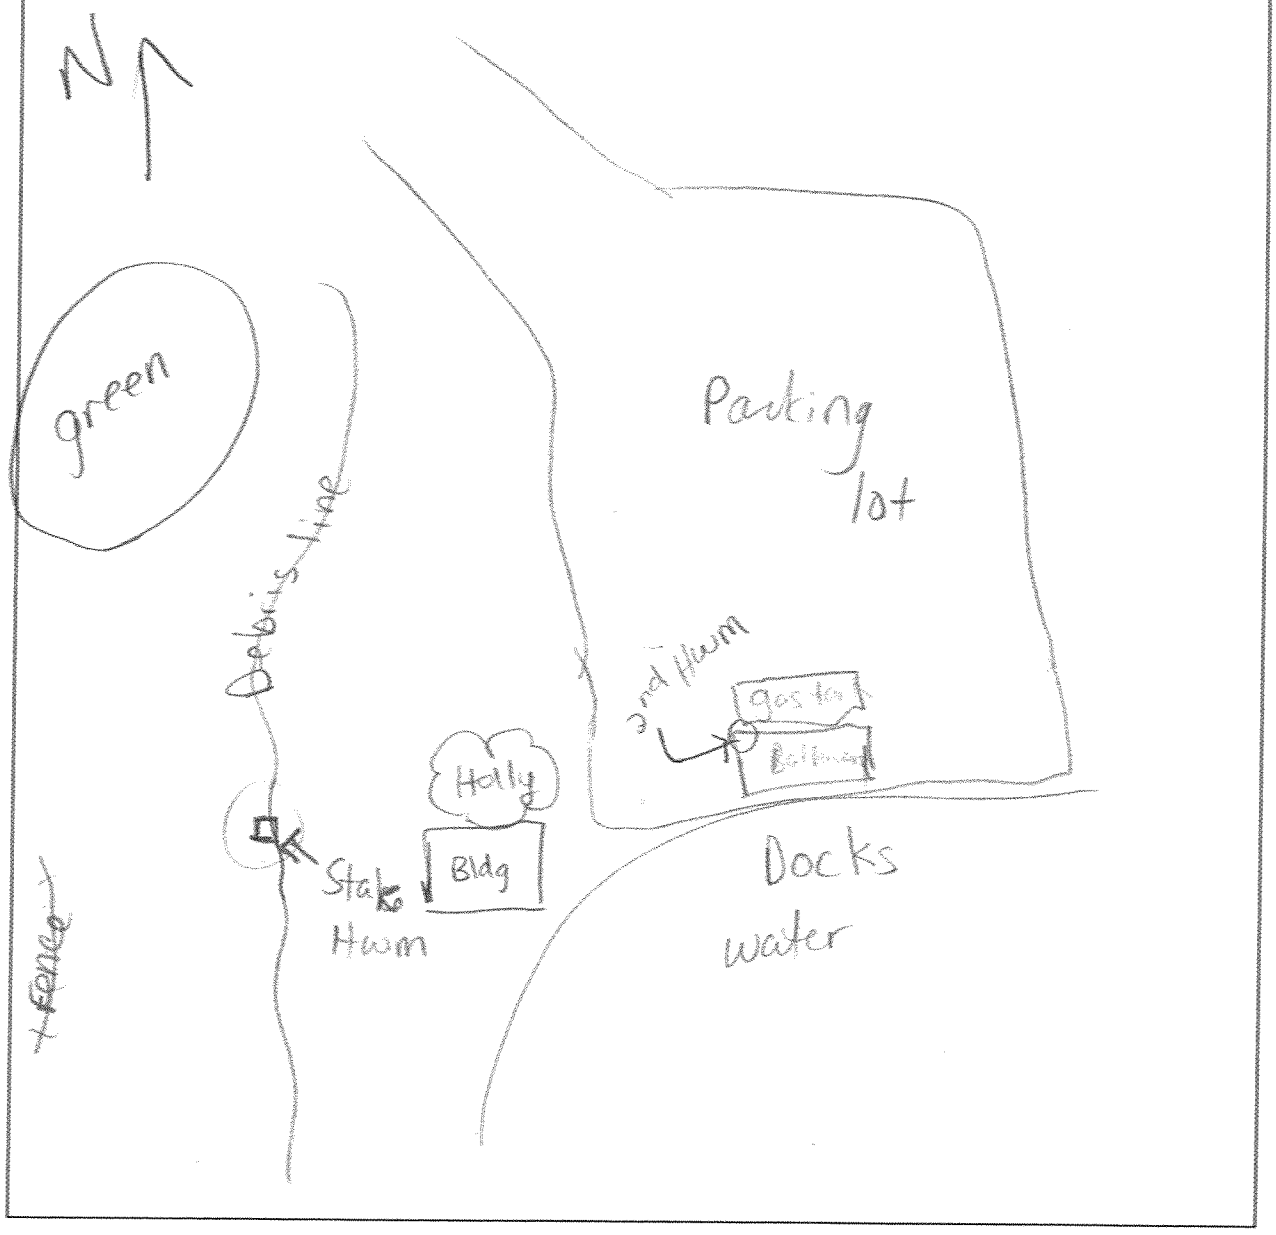
***SITE MAP***

2nd HWM on Bathroom Bldg, in back NW side
N 40.72015, W 073.14092
3.25' up from land surface
