High Water Mark Field Form

SUF-635
Quick Lookup #

DATE: 11/6/2012 STORM: SANDY PARTY: IF & GEK

SITE NAME: HWM-NY-SUF-635 **LATITUDE (DD to 6 places):** 40.77322

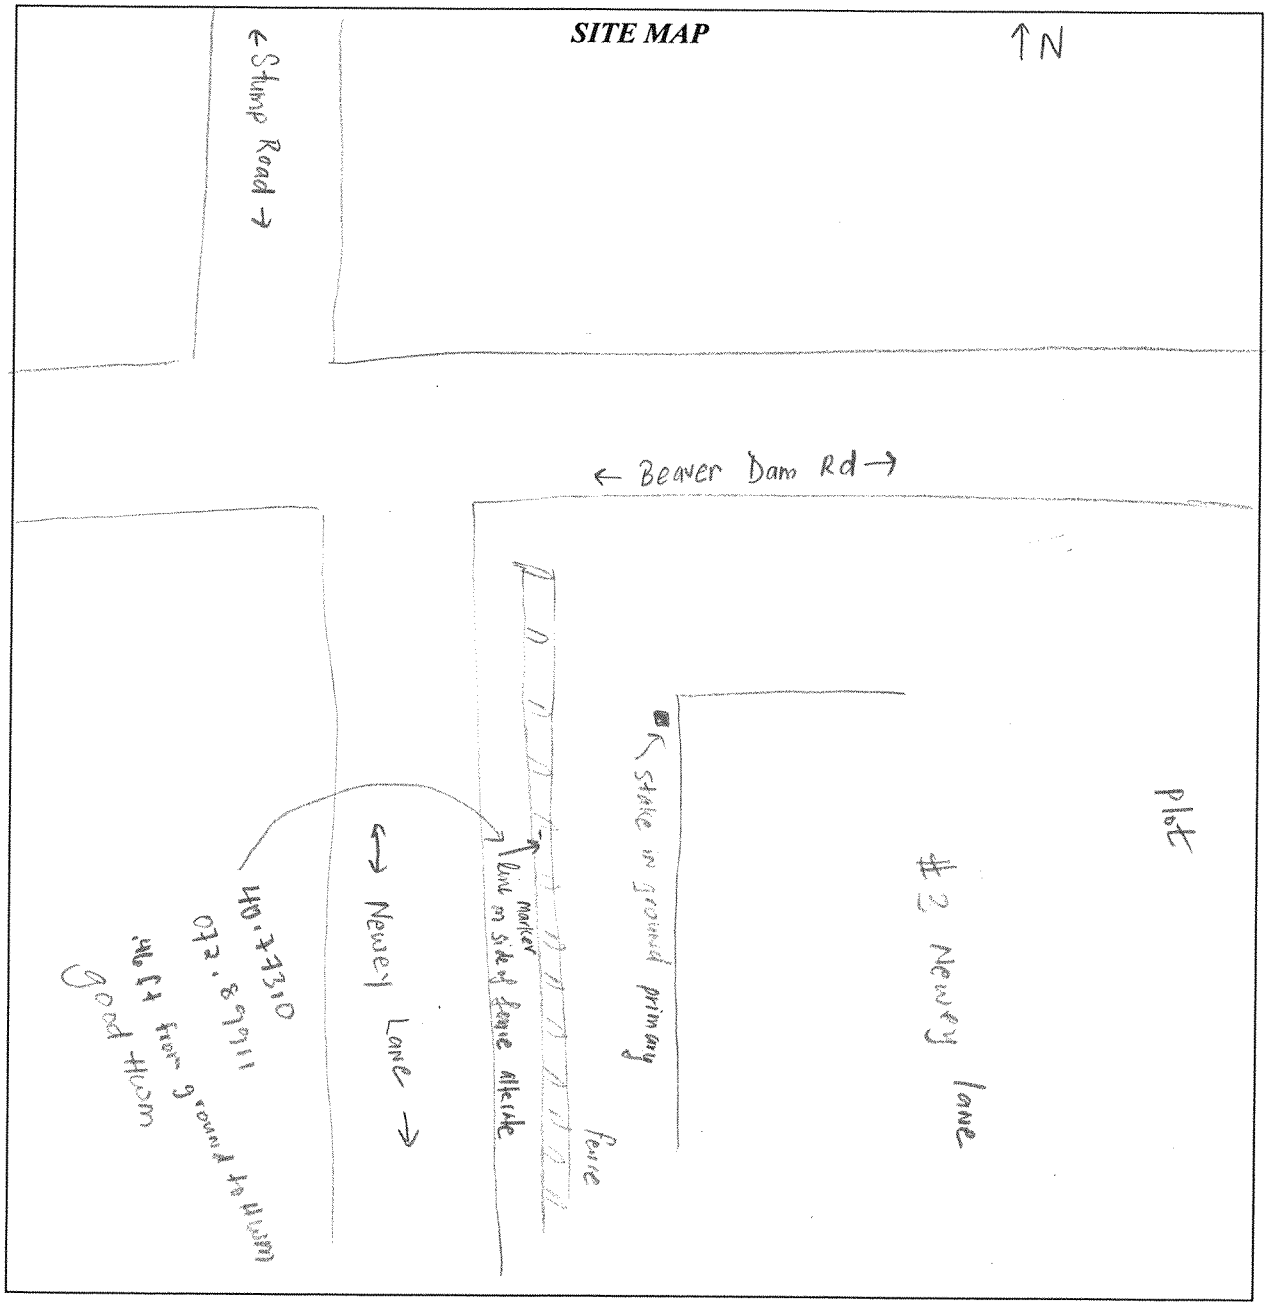
SITE MAP

SITE DESCRIPTION: ON THE (whole side of house) 3 Newey Lane Brookhaven **LONGITUDE (DD to 6 places):** 072.89910

HWM Description: Seed line present on side house of property 3 Newey lane 1.38' from ground + 1.17' from top of stake to HWM
