Oak Beach

High Water Mark Field Form

DATE: 11-05-12 STORM: SANDY PARTY: Shawn + Jason (SCF+JSF)

SITE NAME: HWM-NY-SUF-950 **LATITUDE (DD to 6 places):** 40.63977
(Site Name Format: HWM-SS-COU-###, where SS = state, COU = county, ### = site number)

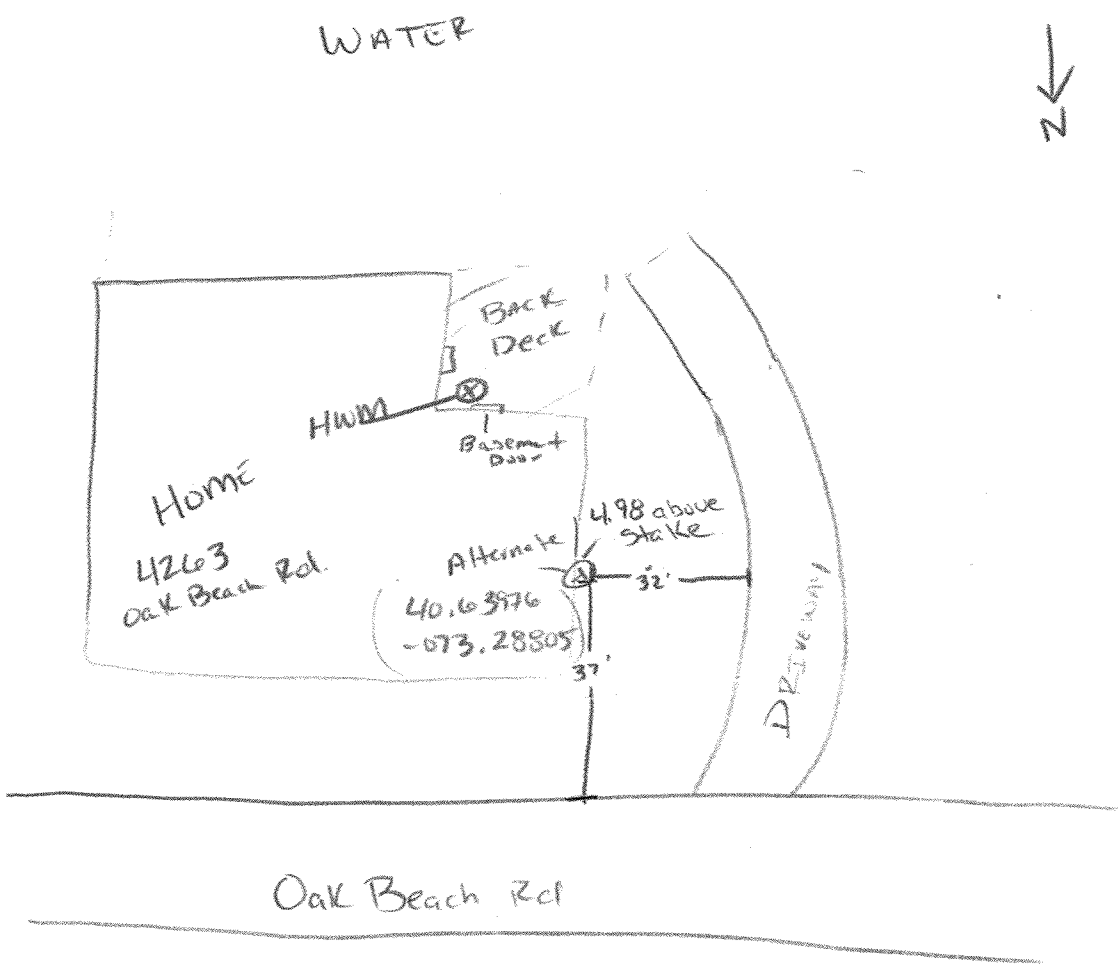
SITE MAP

* Water came from the South. Both stakes at ground level.
Alternate water mark on side of house.
