High Water Mark Field Form

SUF-956
Quick Lookup #

DATE: 11-05-12 STORM: SANDY PARTY: Shawn & Jason (SCF + JSF)

SITE NAME: HWM-NY-SUF-956 **LATITUDE (DD to 6 places):** 40.66481
(Site Name Format: HWM-SS-COU-###, where SS = state, COU = county, ### = site number)

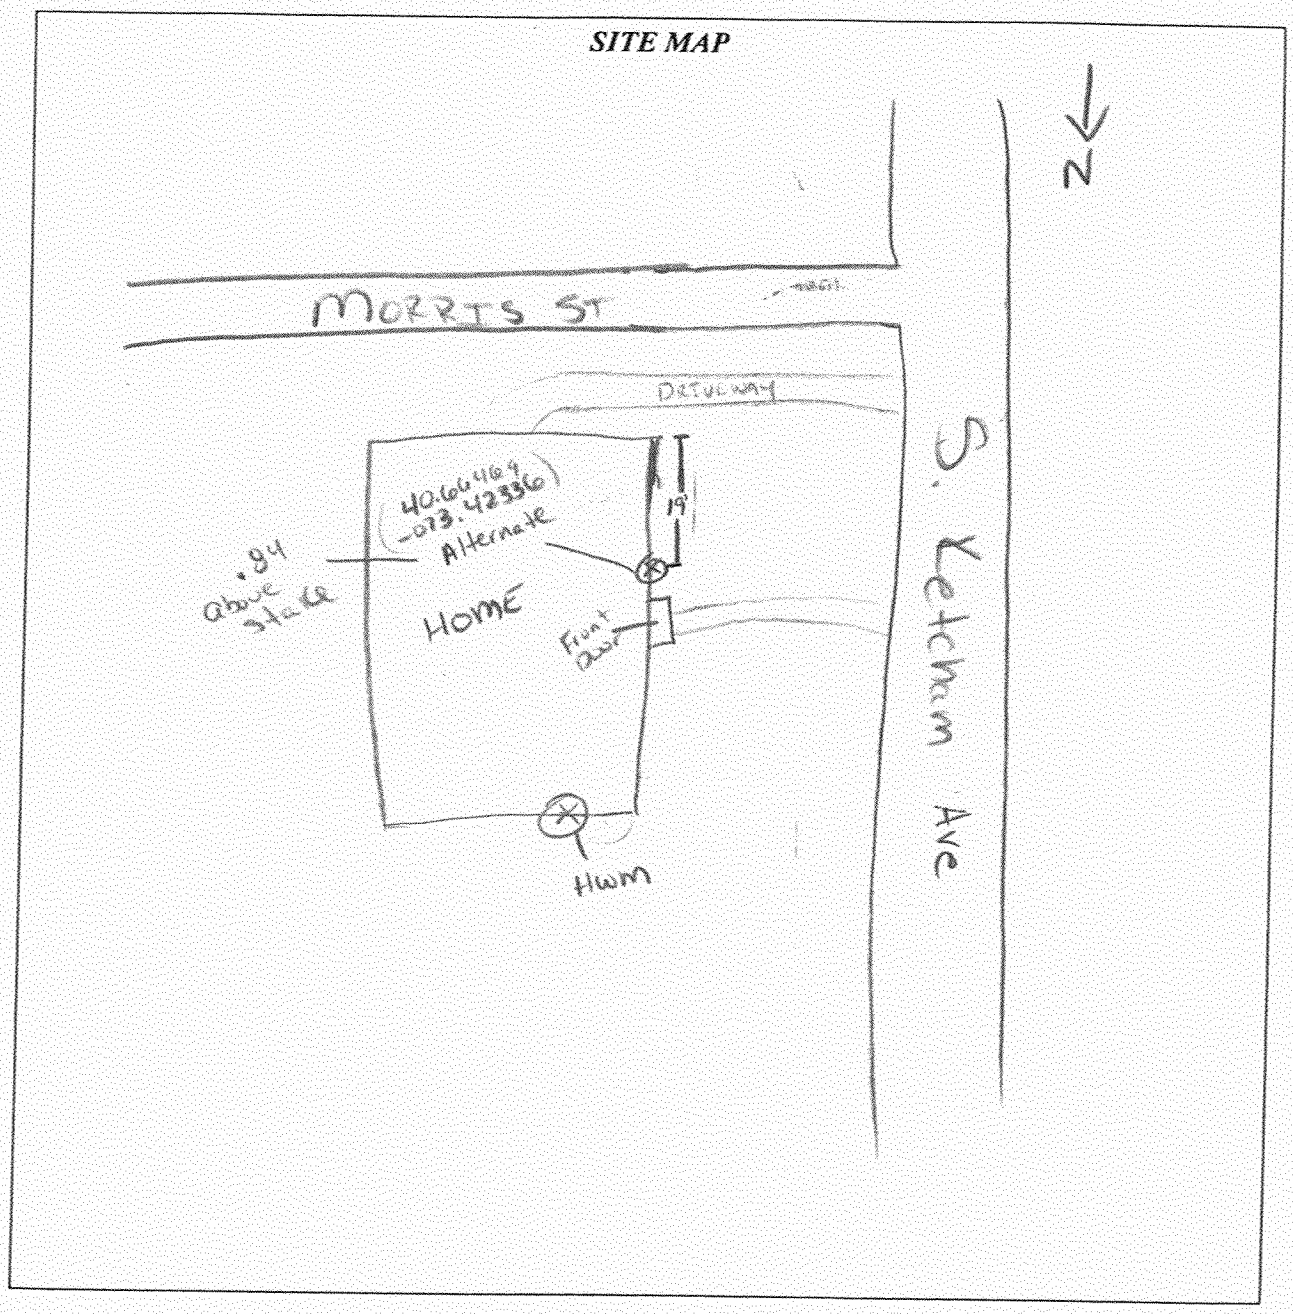
SITE MAP

Address 200 Ketcham Ave Amityville
Both stakes at ground level. Alternate located
South of door.
