High Water Mark Field Form

DATE: 11/2/2012 STORM: SANDY PARTY: CCR/UMD

SITE NAME: HWM-VA-ACC-056 **LATITUDE (DD to 6 places):** 37.72195°
(Site Name Format: HWM-SS-COU-###, where SS = state, COU = county, ### = site number)

SITE DESCRIPTION: HOLLY COVE **LONGITUDE (DD to 6 places):** 75.78580°

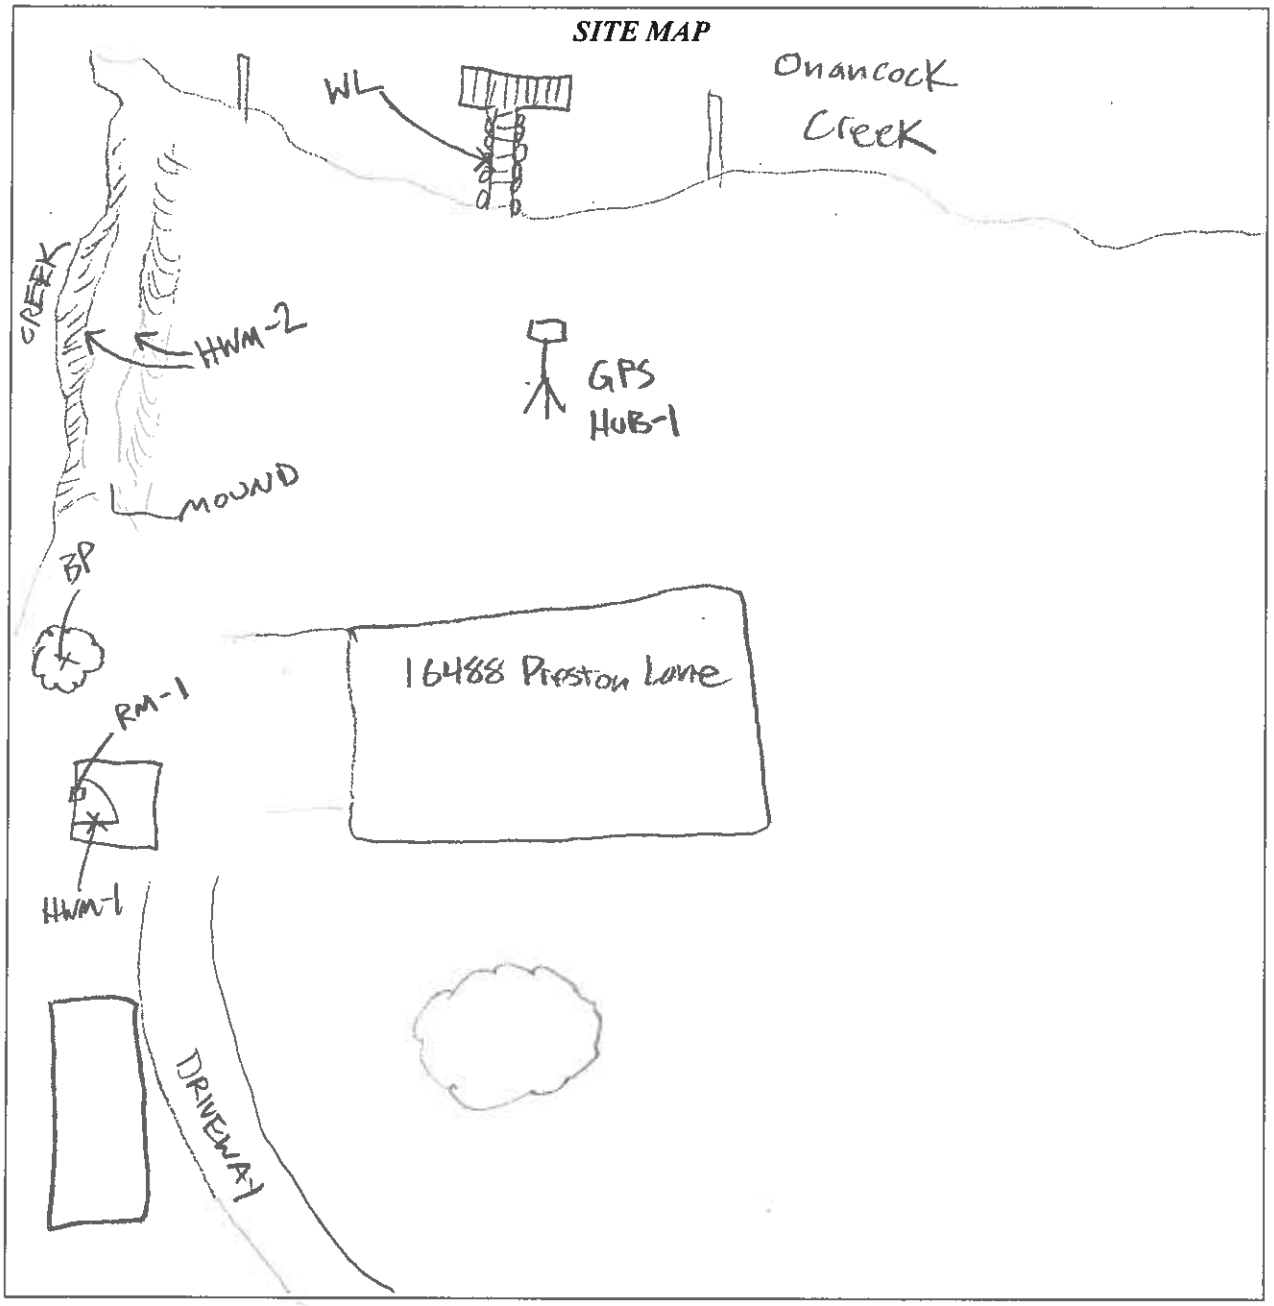
RM-1 is chisel square on brick foundation of storage shed, in doorway, on left side looking in.
OPUS: 0958~1046
