**High-Water Mark Documentation**

Road name: MAIN ST. & LAKE AVE.

Site number: HWM-NJ-MON-107

Municipality: Asbury Park

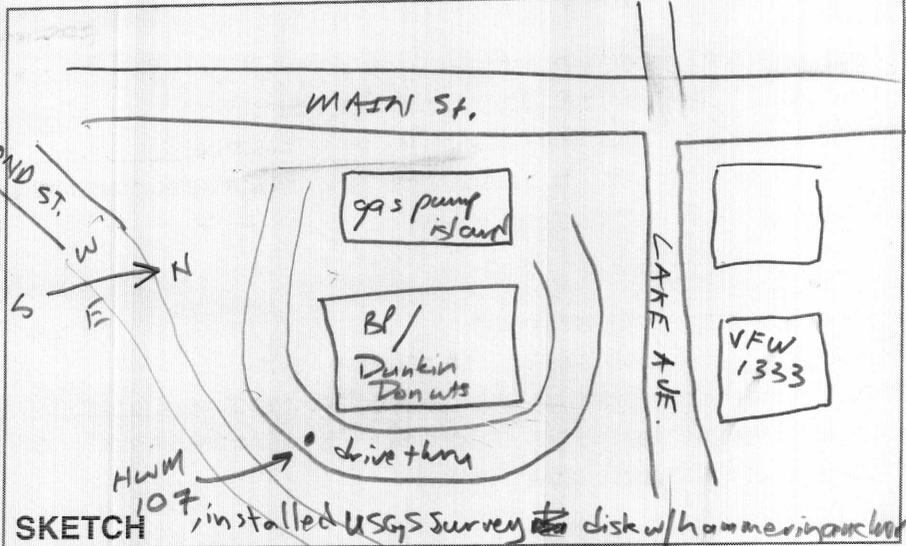
Shot 1 10.518'  
Shot 2 10.501' }  $\bar{x} = 10.510'$

10° deg slope of concrete  
drive thru lane in parking lot.

hammer anchor w/ USGS survey disk

crossed center of Bond St.

SKETCH installed USGS survey disk w/hammer anchor
