# High Water Mark Field Form

DATE: 11/05/12 STORM: Sandy PARTY: RRB, MLN

SITE NAME: HWM-NY-BRO-809 LATITUDE (DD to 6 places): 40° 48' 55.41" N  
(Site Name Format: HWM-SS-COU-###, where SS = state, COU = county, ### = site number)

SITE DESCRIPTION: Ferry Point Park LONGITUDE (DD to 6 places): 73° 50' 19.04" W

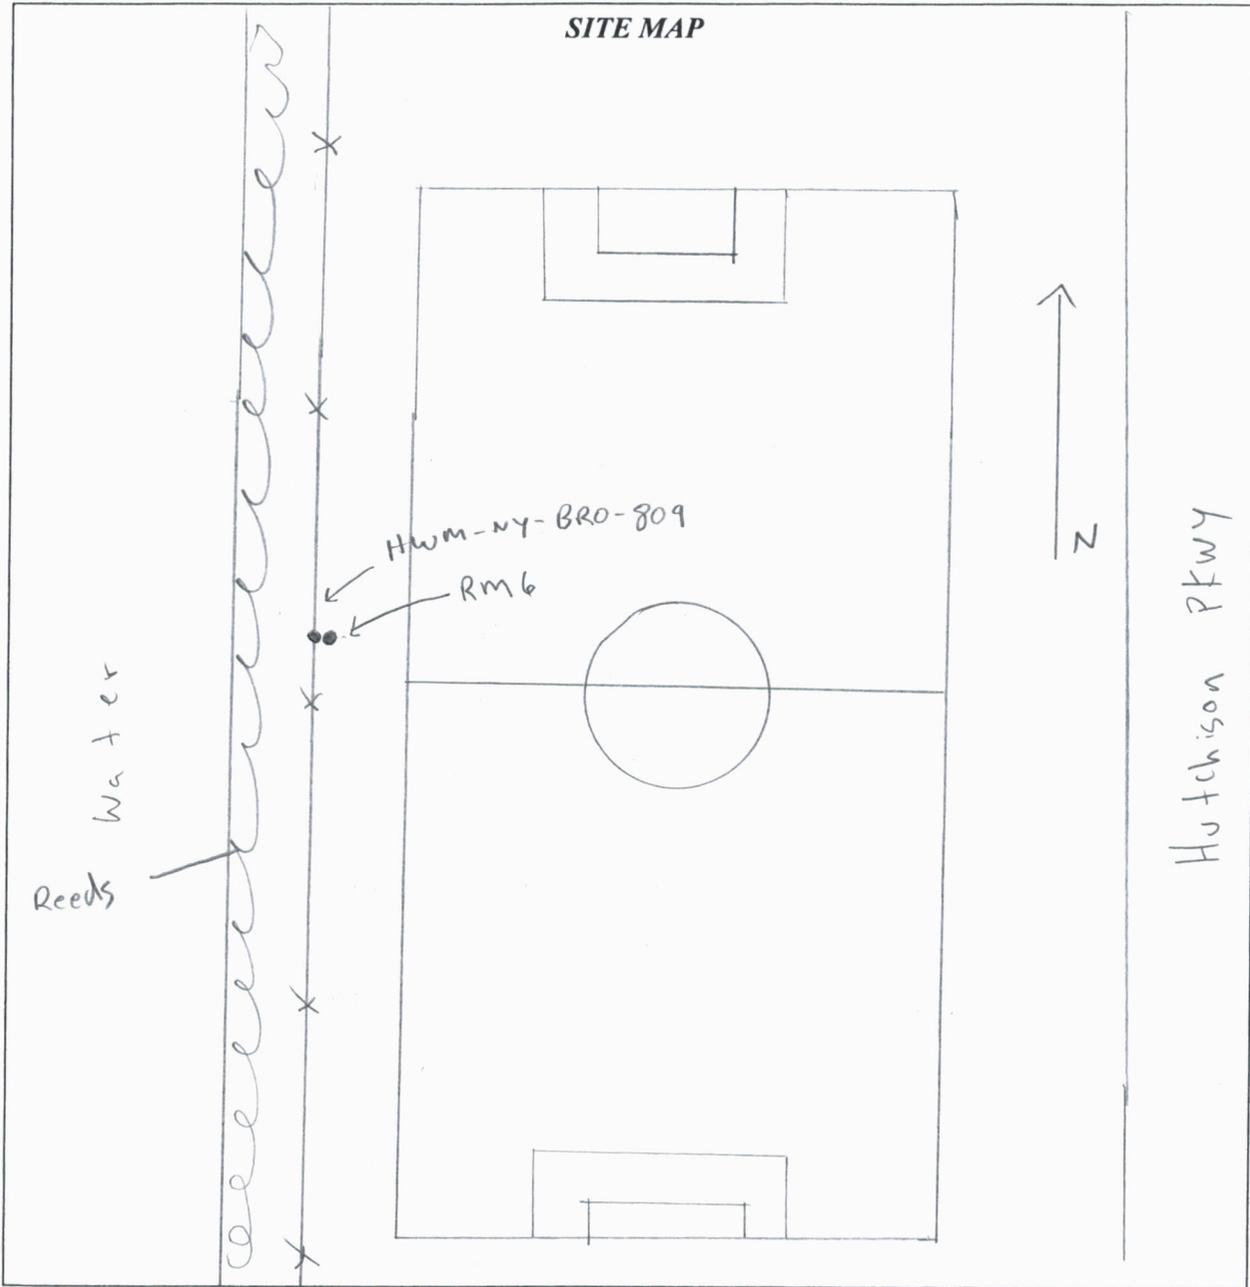
HWM Description: HWM is debris line on fence west side of soccer field east of water.

Stake put in @ L.S. = Rm 6 took tape up to  
HWM 809 = 3.39 ft above L.S.
