ASSESSMENT OF KARST FEATURES UNDERLYING LAKE SEMINOLE, SOUTHWESTERN GEORGIA AND NORTHWESTERN FLORIDA, USING ORTHORECTIFIED PHOTOGRAPHS OF PREIMPOUNDMENT CONDITIONS AND HYDROGRAPHIC MAPS

Lynn J. Torak

AUTHOR: Hydrologist, U.S. Geological Survey, 3039 Amwiler Road, Suite 130, Peachtree Business Center, Atlanta, Georgia 30360-2824.
REFERENCE: *Proceedings of the 2003 Georgia Water Resources Conference*, held April 23–24, 2003, at the University of Georgia. Kathryn J. Hatcher, editor, Institute of Ecology, The University of Georgia, Athens, Georgia.

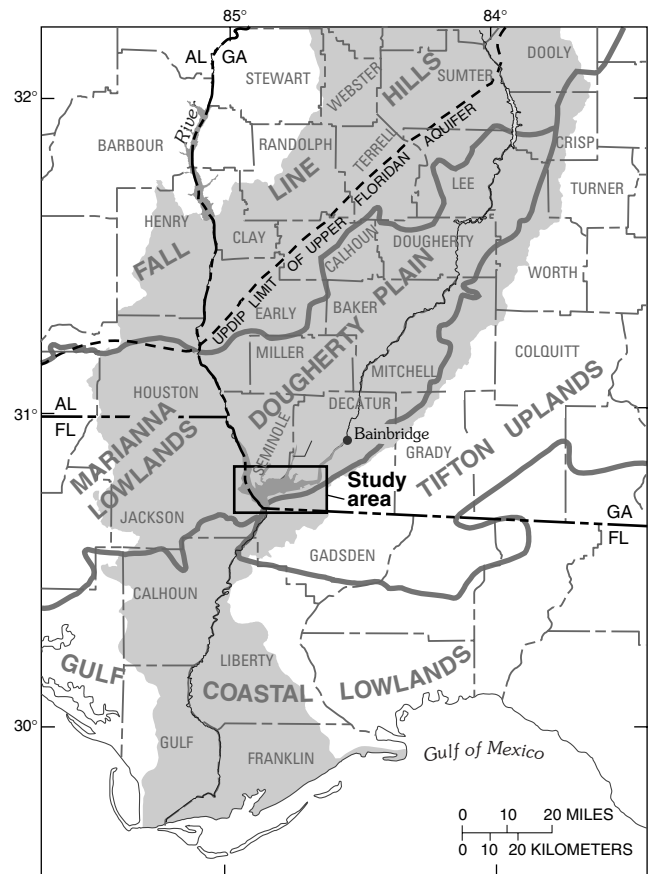
Figure 1. Location of study area, boundaries of the lower Apalachicola–Chattahoochee–Flint River Basin, and physiographic districts of the Coastal Plain Province (modified from Torak and others, 1996).

Lake Seminole is a 37,600-acre lake located along the Georgia-Florida State line in extreme southwestern Georgia and northwestern Florida (Fig. 1). The lake was filled to its normal-pool elevation of 77 feet in 1957 following construction, by the U.S. Army Corps of Engineers (Corps), of Jim Woodruff Lock and Dam on the Apalachicola River, about 1,000 feet downstream of the confluence of the Flint and Chattahoochee Rivers (U.S. Army Corps of Engineers, 1981). Primarily built to aid navigation and generate hydroelectric power for neighboring communities, Lake Seminole is the headwater of the Apalachicola River and provides about 33 feet of lift to vessels traveling upstream through the lock and dam into the lake (U.S. Army Corps of Engineers, 1981).

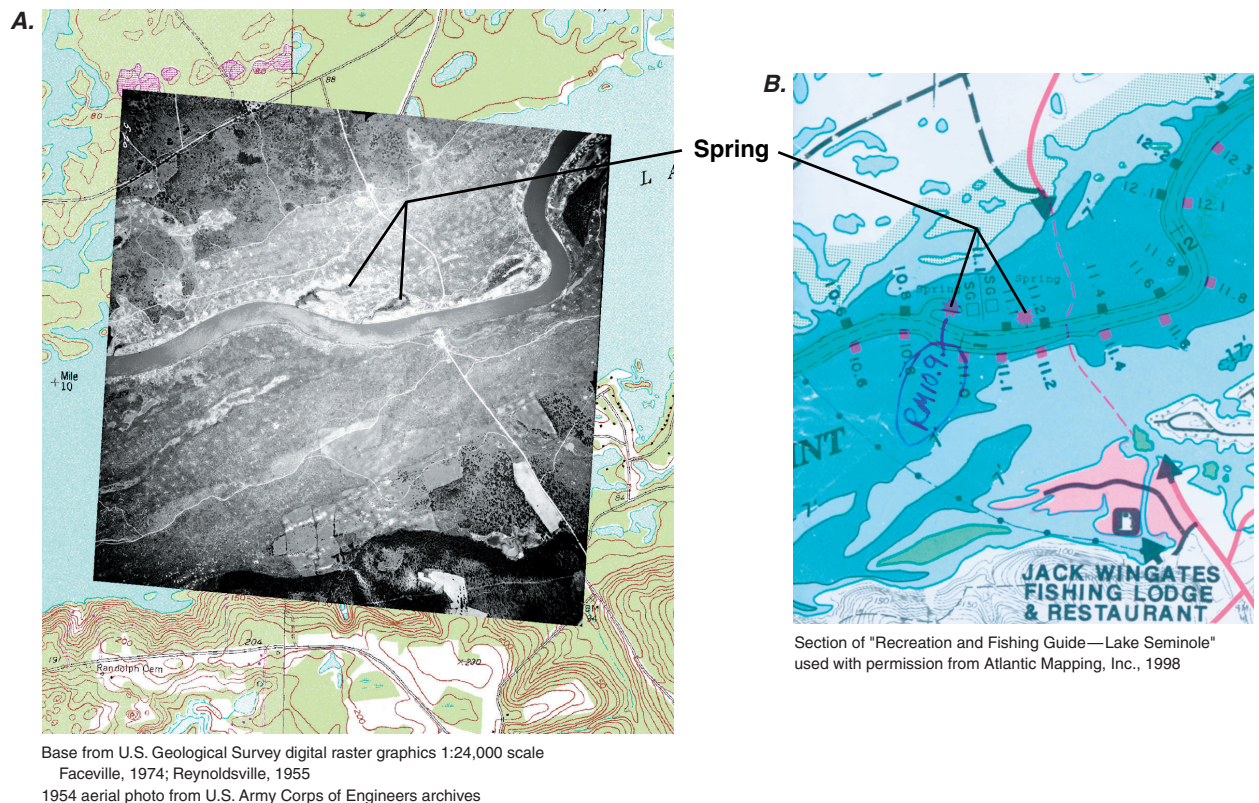
Figure 2. (A) Orthorectified aerial photograph and Digital Raster Graphics image of 1:24,000-scale topographic map of Lake Seminole area, preimpoundment conditions along Flint River downstream of Bainbridge, Georgia, showing river channel and springs; and (B) map showing bathymetric features of Flint River impoundment arm to Lake Seminole, downstream of Bainbridge, Georgia.

Orthorectified photographs of the lake area prior to impoundment show details of karst features in the now-impounded lake bottom that are not evident on topographic maps or maps showing navigation features. The irregular morphology of springs and spring runs, which once discharged to the Flint River and now discharge to the lake bottom, is clearly visible in the aerial photo-

graphs (Fig. 2A). These springs are identified with point symbols on maps showing general navigation features and bathymetry (Fig. 2B), and springs in the lake area (Sever, 1965, plate 1). The aerial photographs indicate ponding and channelized springflow in a run that discharged to the then-Flint River (Fig. 2A). Identification of springs in the aerial photographs was aided by evaluating the extent of tree clearing performed in the unimpounded area, as there was a conspicuous lack of tree clearing near springs and spring runs.

Aerial photographs of the preimpoundment area of Lake Seminole show a more extensive hydraulic connection between the Upper Floridan aquifer and Flint River by springs, spring runs, and ponds than is shown on available maps (Fig. 2). Preimpoundment aerial photographs of the construction area for Jim Woodruff Lock and Dam show visual details of stream-aquifer

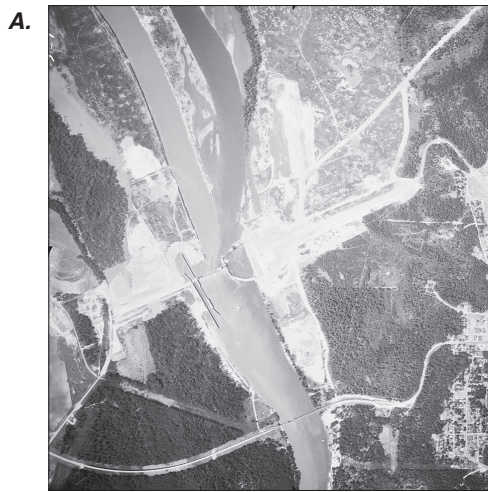
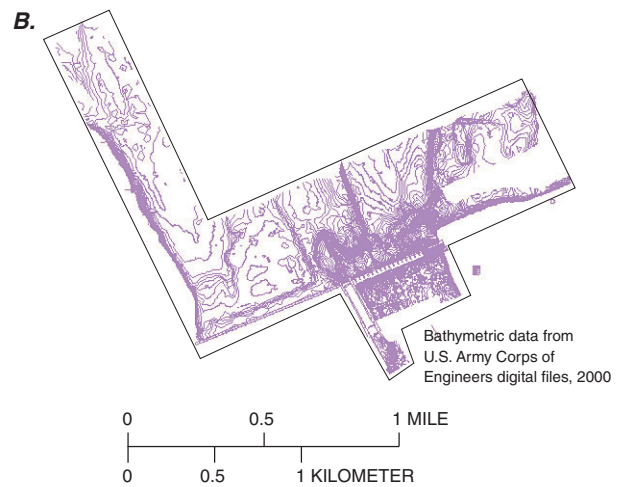
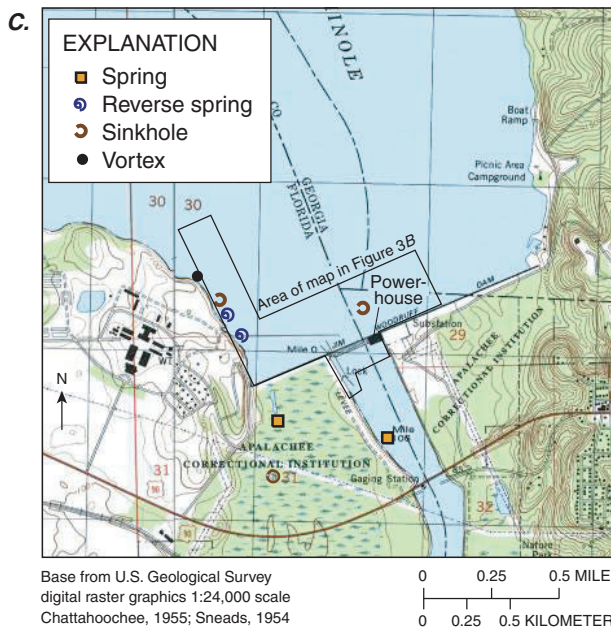
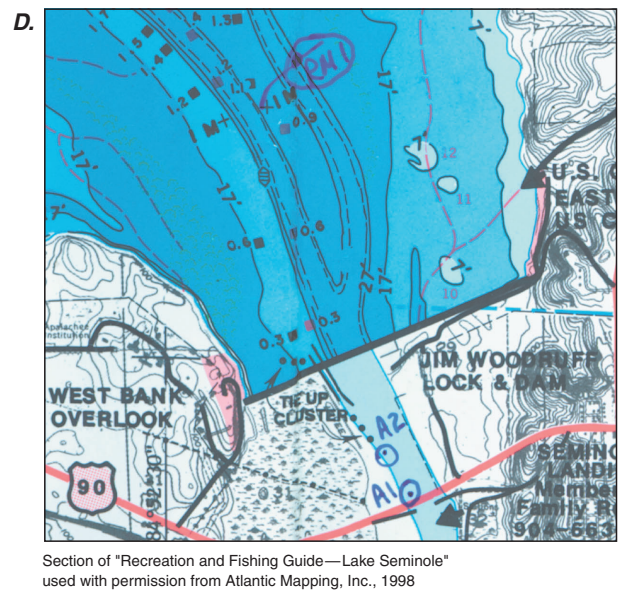
Figure 3. (A) Aerial photograph of construction site of Jim Woodruff Lock and Dam, 1954; (B) bathymetric map of impounded area directly behind Jim Woodruff Lock and Dam and along western shore of Lake Seminole (area shown in Figure 3C); (C) Digital Raster Graphics image of 1:24,000-scale topographic map of Lake Seminole showing area encompassing Jim Woodruff Lock and Dam and location of vortex, sinkholes, and reverse springs adjacent to dam; and (D) map showing navigation and bathymetric features of Lake Seminole near Jim Woodruff Lock and Dam.

Hydrographic maps were compared with the orthorectified aerial photographs and map showing navigation features (Fig. 3A–D). The hydrographic maps depicted lake-bottom features in the area directly upstream of Jim Woodruff Lock and Dam and along the western shore.

Aerial photographs and hydrographic maps in the area of the lock and dam show steep lake bathymetry along the western lakeshore and an irregular lake bottom resembling former channels of the Chattahoochee and Flint Rivers directly upstream of the dam (Fig. 3A, B). Subsurface structures resembling sinkholes that function as reverse springs, leaking water from the lake into the underlying limestone, were identified on hydrographic maps and were identified during inspection of the western lakeshore (Fig. 3B, C). Other structures

resembling sinkholes or former stream-channel incisions were identified just upstream of the powerhouse (Fig. 3C). At one sinkhole location near the western lakeshore (Fig. 3B), water leaking to the underlying limestone created a small vortex in the lake surface. Although the vortex was a surface expression of lake leakage, the amount of leakage seemed to be minor. The vortex itself has been reported to form only during "ideal" conditions when the lake level is low, creating shallow water above the area of leakage (James H. Sanders, Jr., Geologist, U.S. Army Corps of Engineers, Mobile District, Mobile, Alabama, written commun., 2002). Bathymetric expressions of these features are not identified with the general-depth contours of the map showing navigation channels (Fig. 3D). Aerial photographs of the preimpounded lake area (Fig. 3A) were used to identify the location of several springs along the western lakeshore that were described by the Corps during construction of the lock and dam (U.S. Army Corps of Engineers, 1948, Appendix II, Chart 1.1).

hydraulic connection that are absent from maps showing topography, navigation features, and bathymetry (Fig. 3), and support previously published accounts by Sever (1965) and the Corps (U.S. Army Corps of Engineers, 1948) of the solutioned karst landscape. Identification of karst features in preimpoundment aerial photographs corroborates their appearance on hydrographic maps and gives strong evidence for an active stream-aquifer hydraulic connection in the Lake
